**HERITAGE IMPACT ASSESSMENTS
SOLIHULL METROPOLITAN BOROUGH COUNCIL
LOCAL PLAN REVIEW**

**REPORT No 4: SITE 12 DOG KENNEL LANE, SHIRLEY
MARCH 2019**

HERITAGE IMPACT ASSESSMENT: SITE 12 – DOG KENNEL LANE, SHIRLEY

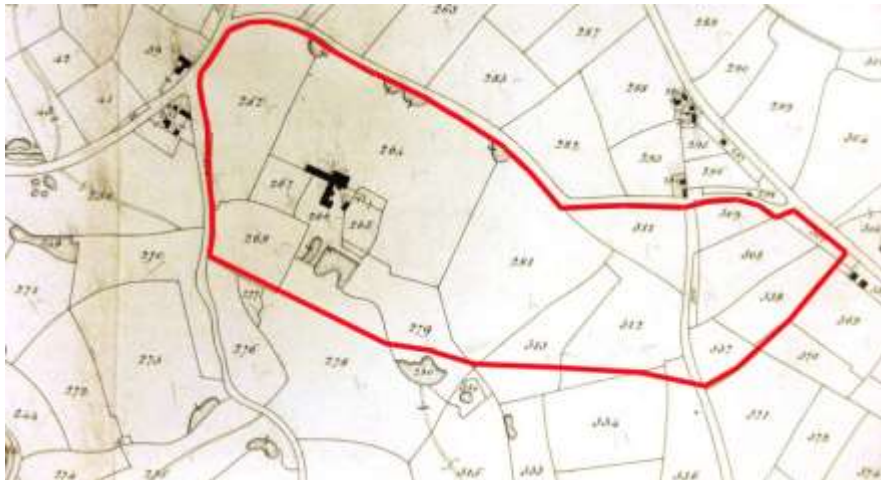
Figure 9 1842 Tithe map of Tanworth in Arden with Site 12 overlaid in red

4.4.4 By the time of the Tithe Map (1842), Light Hall and the surrounding fields were owned by The Right Honourable Earl Cornwallis and occupied by John Stringer. At this time the house (Parcel 266) is described as Yards, Pleasure Grounds and Buildings. The field names are broadly comparable to those shown fifty years earlier. At this time Burman is still a large landowner – in this case Sarah Burman who owned most of the land between the (still existing) green lane and the Stratford Road at Monkspath.

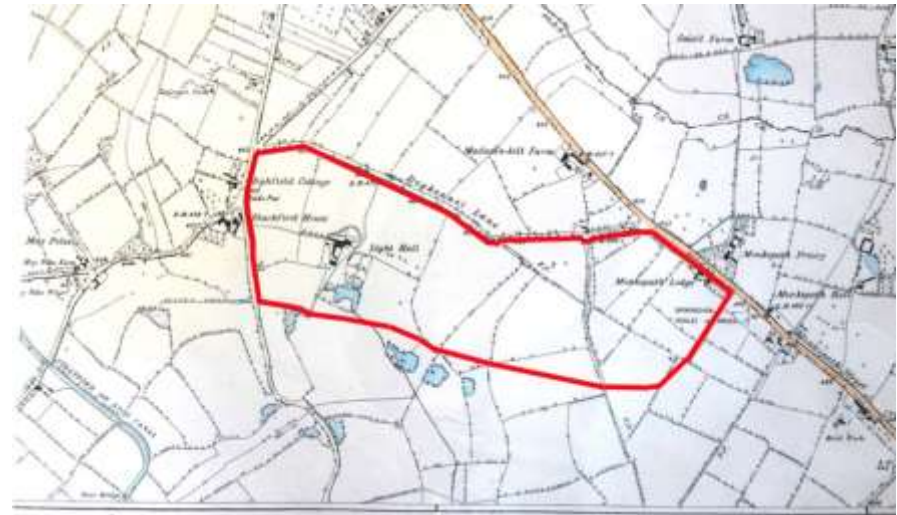
Figure 10 1st Edition Ordnance Survey Sheet 1884 with Site 12 overlaid in red

4.4.5 The first edition Ordnance Survey map 1884 shows the area in more detail but the field patterns are recognisable from the earlier maps as is the general layout of buildings and the immediate surroundings of the house.

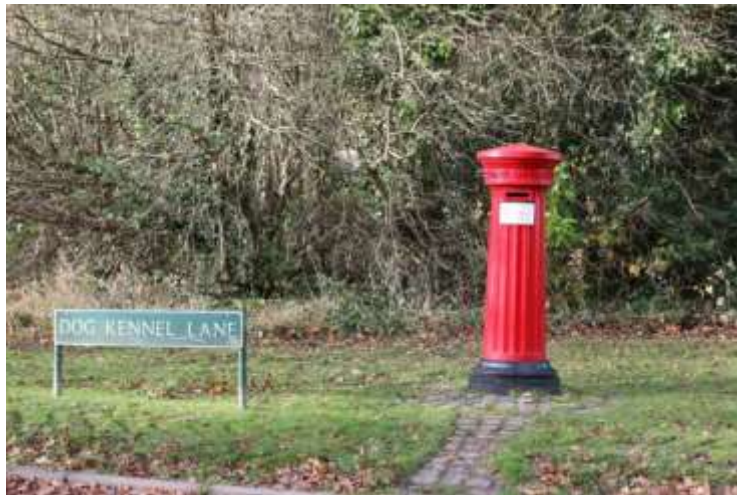
Figure 11 Grade II Listed Pillar Box at east end of Dog Kennel Lane

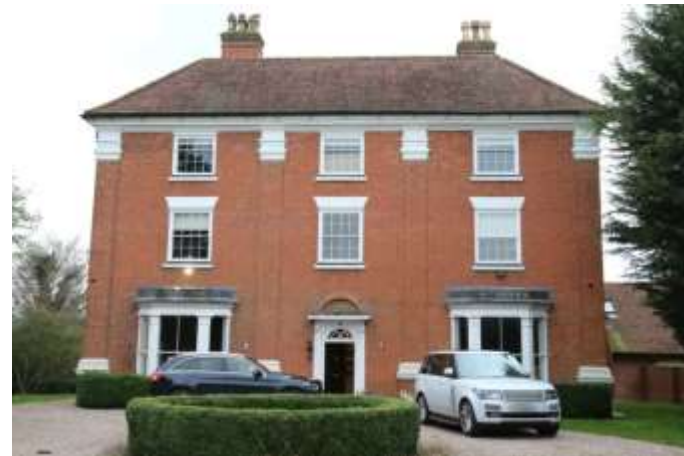
Figure 12 Light Hall north front elevation

- 4.6.9 Light Hall itself is of considerable interest. The front north elevation is elegant with raised brick pilasters with moulded plinths and capitals and a moulded cornice. Its appearance is different to that shown in the 1794 survey (compare Figures 2 and 9). The ground floor sash windows have been replaced by bays and a door case with scrolled fanlight, flat pilasters, moulded brackets and flat hood has been installed. The original fanlight has been replaced although the original semi-circular brick arch remains above the door case. The rear elevation has sash windows at first and second floor, the outer sashes also having sidelights. Ground floor windows are casements and a late C20th open porch has been added (Figure 11). The east side elevation has different casement window styles at ground floor and

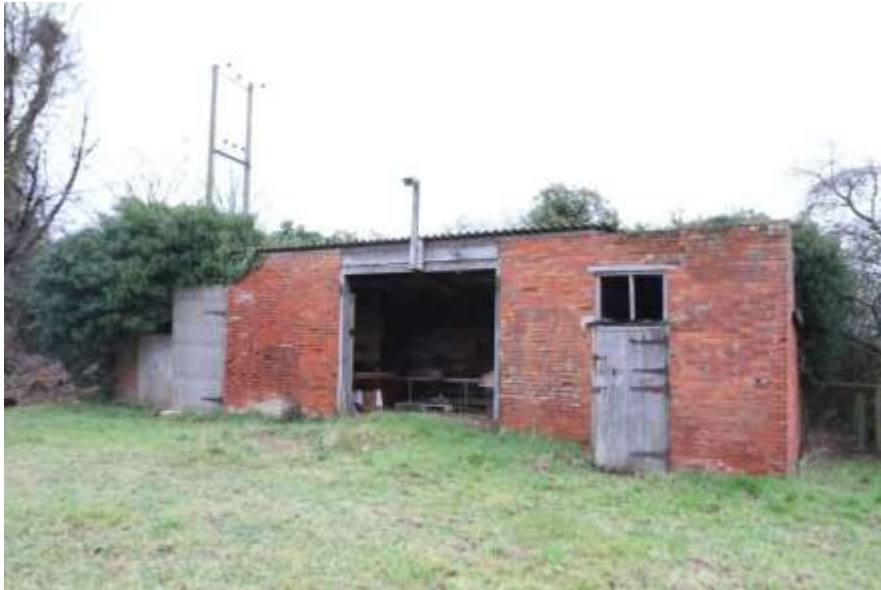
Figure 16 Light Hall; outbuilding adjacent to former walled garden

- 4.6.10 Beyond the drive, south-east of the house are the remains of an outbuilding with a short section of wall at its north-west corner. West of this wall are the remnants of a low wall, now obscured by undergrowth and ivy but with an opening for a gate just visible. This building and the walls are the ground floor of the outbuilding shown to the left of the main house in Figure 5, which also shows a wall with battlements or crenellations. If this feature is still extant it is covered with ivy and hence is obscured. The walled garden which is shown as parcel 265 on the Tithe map and is shown on the 1884 Ordnance Survey map had paths dividing the walled garden into four compartments. It is not clear that any other remnants of the garden wall or the paths remain visible.
