**HERITAGE IMPACT ASSESSMENTS  
SOLIHULL METROPOLITAN BOROUGH COUNCIL  
LOCAL PLAN REVIEW**

**REPORT No 2: SITE 3 - WINDMILL LANE, BALSALL COMMON  
MARCH 2019**

## HERITAGE IMPACT ASSESSMENT: SITE 3 – WINDMILL LANE, BALSALL COMMON

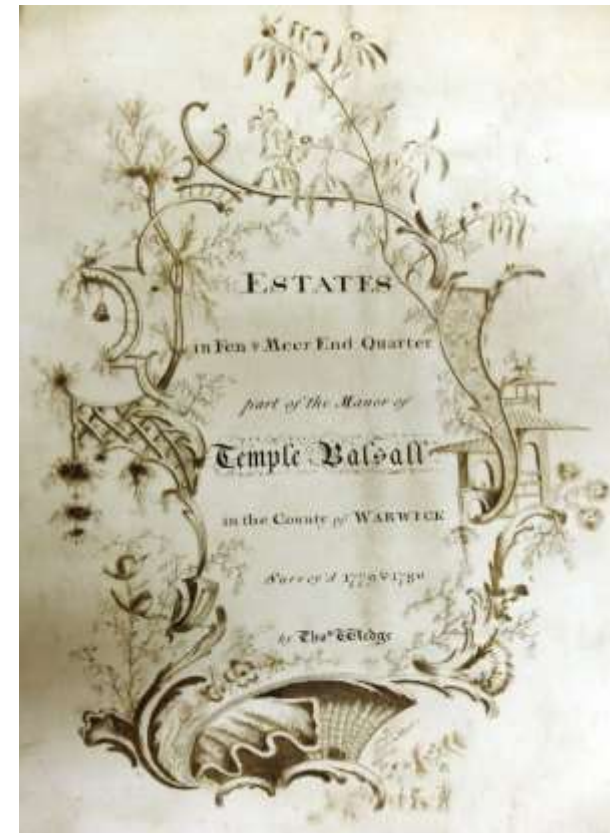
Figure 5 Title Block of 1779-1780 survey

2.4.3 The 1779-1780 survey (Figures 5-7) covers a wide area which extends some distance beyond Site 3. Kenilworth Road is shown (running through the words Windmill Hill) as is its junction with what is now Kelsey Lane. At this point **on the map it is annotated as "DANES BANK". Windmill**

Lane, being in Berkswell parish, is not shown but two oak trees are marked at its junction with the Kenilworth Road, **namely SOLOMON'S OAK and CHILD'ES OAK. The windmill is clearly shown and is depicted as such near to the annotation "WINDMILL HILL". The boundary between the two parishes is clearly marked as being defined by "Meer Stones"**

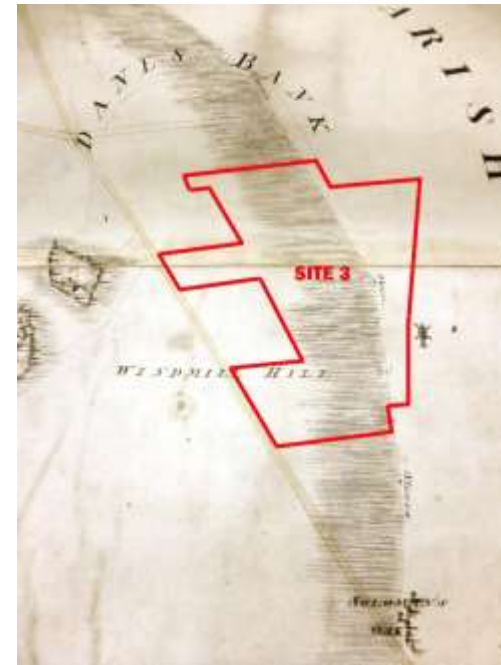
Figure 6 extract of 1779-1780 Survey

Figure 7 Extract from 1779-1780 survey to show Windmill, SOLOMON'S OAK and CHILD'S OAK

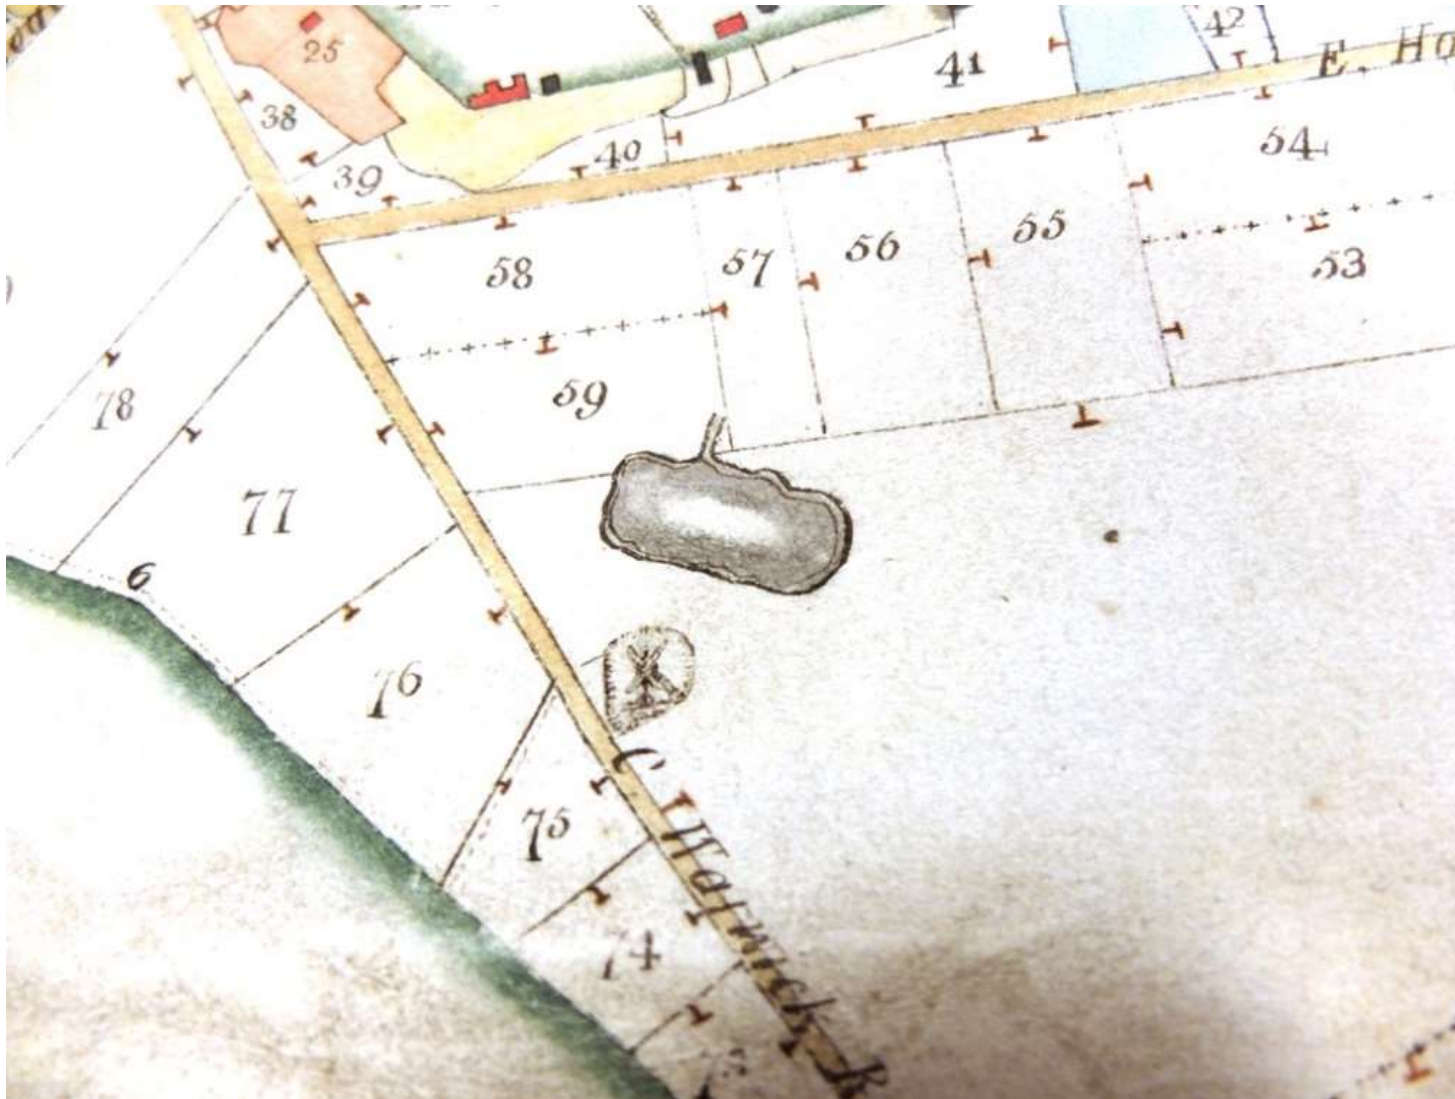
Figure 9 Detailed extract from 1802 Berkswell Inclosure Map to show windmill. NB on this map the footpath between Windmill Lane and Kenilworth Road that still exists can clearly be seen between field parcels 75 & 76. The “water feature” north of the windmill can still clearly be seen from the windmill.

2.4.4 The 1802 Balsall Common Inclosure map (Figures 8-9) is **more concerned with land around Site 1 (Barratt's Farm)** and as such land ownerships around Site 3 are not marked as clearly as they are in Site 1. However, the windmill is shown with a large pond nearby (off what is now Hob Lane) and is associated with a larger area of land to the east, Parcel 60. NB On this map Windmill Lane is shown as Warwick Road and Hob Lane is shown as E. Hob Lane Road. The windmill is clearly shown as is the footpath between field parcels 75 and 76 that still exists.

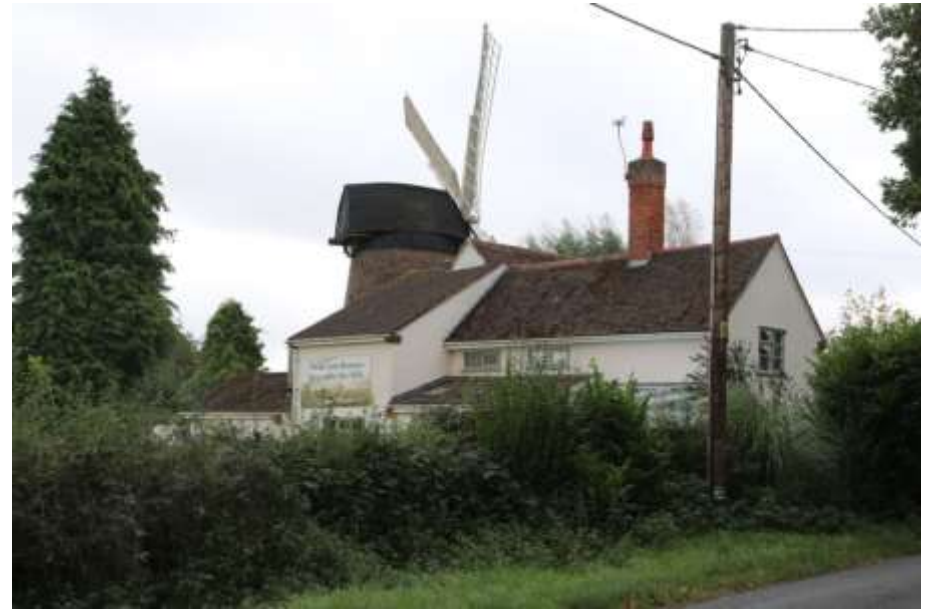
Figure 13 Berkswell Windmill from north looking south

2.6.2 Berkswell Windmill has a brick tower with a timber cap and stands on a brick 'plinth' about 600mm above the surrounding ground level. North of the mill is the cottage where the mill's owners live. East of the mill are two small brick outbuildings which the owner says were used as a dairy by an early owner of the current mill. South of the mill are two small paddocks.

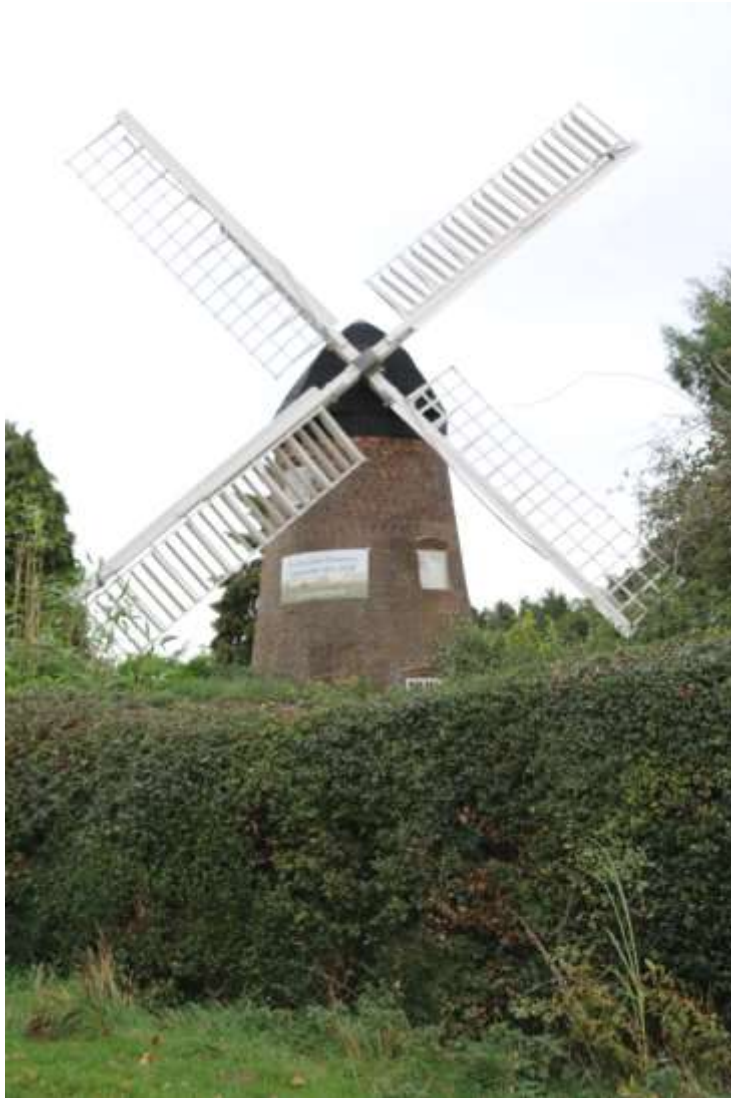
Figure 14 Berkswell Windmill from Windmill Lane adjacent to mill

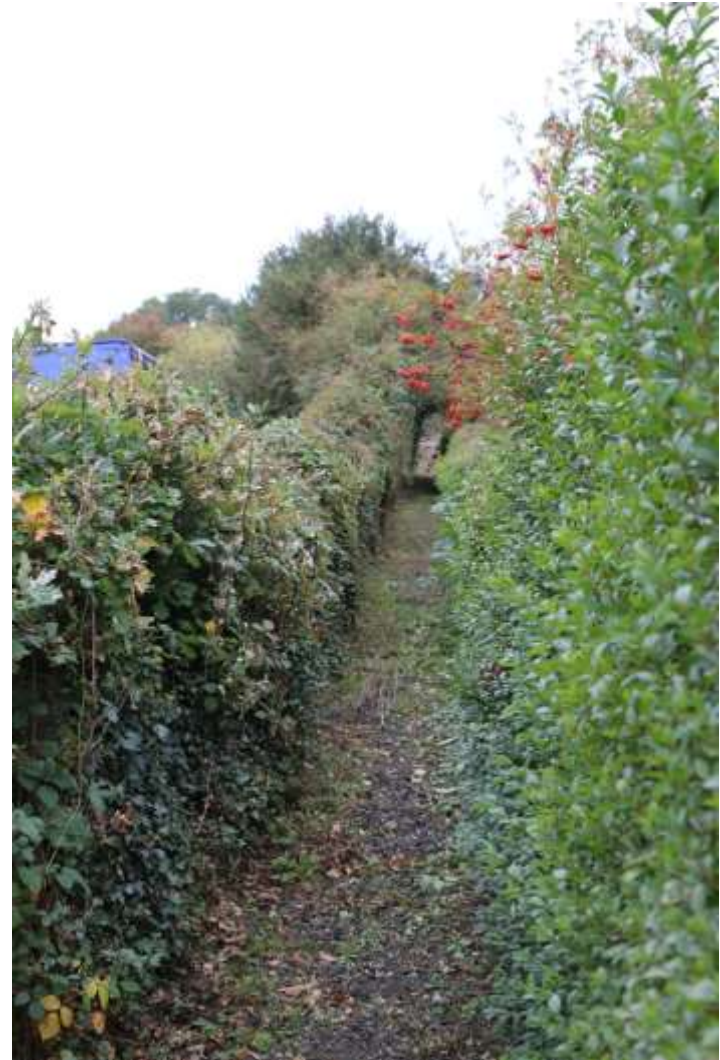
Figure 15 Public footpath from Windmill Lane to Kenilworth Road, opposite windmill

2.6.11 There are views of the windmill from parts of the paddocks between Windmill Lane and Kenilworth Road and as evidenced by Figure 15 there are very clear views from the windmill to the paddocks alongside Windmill Lane immediately south of the footpath opposite the mill.

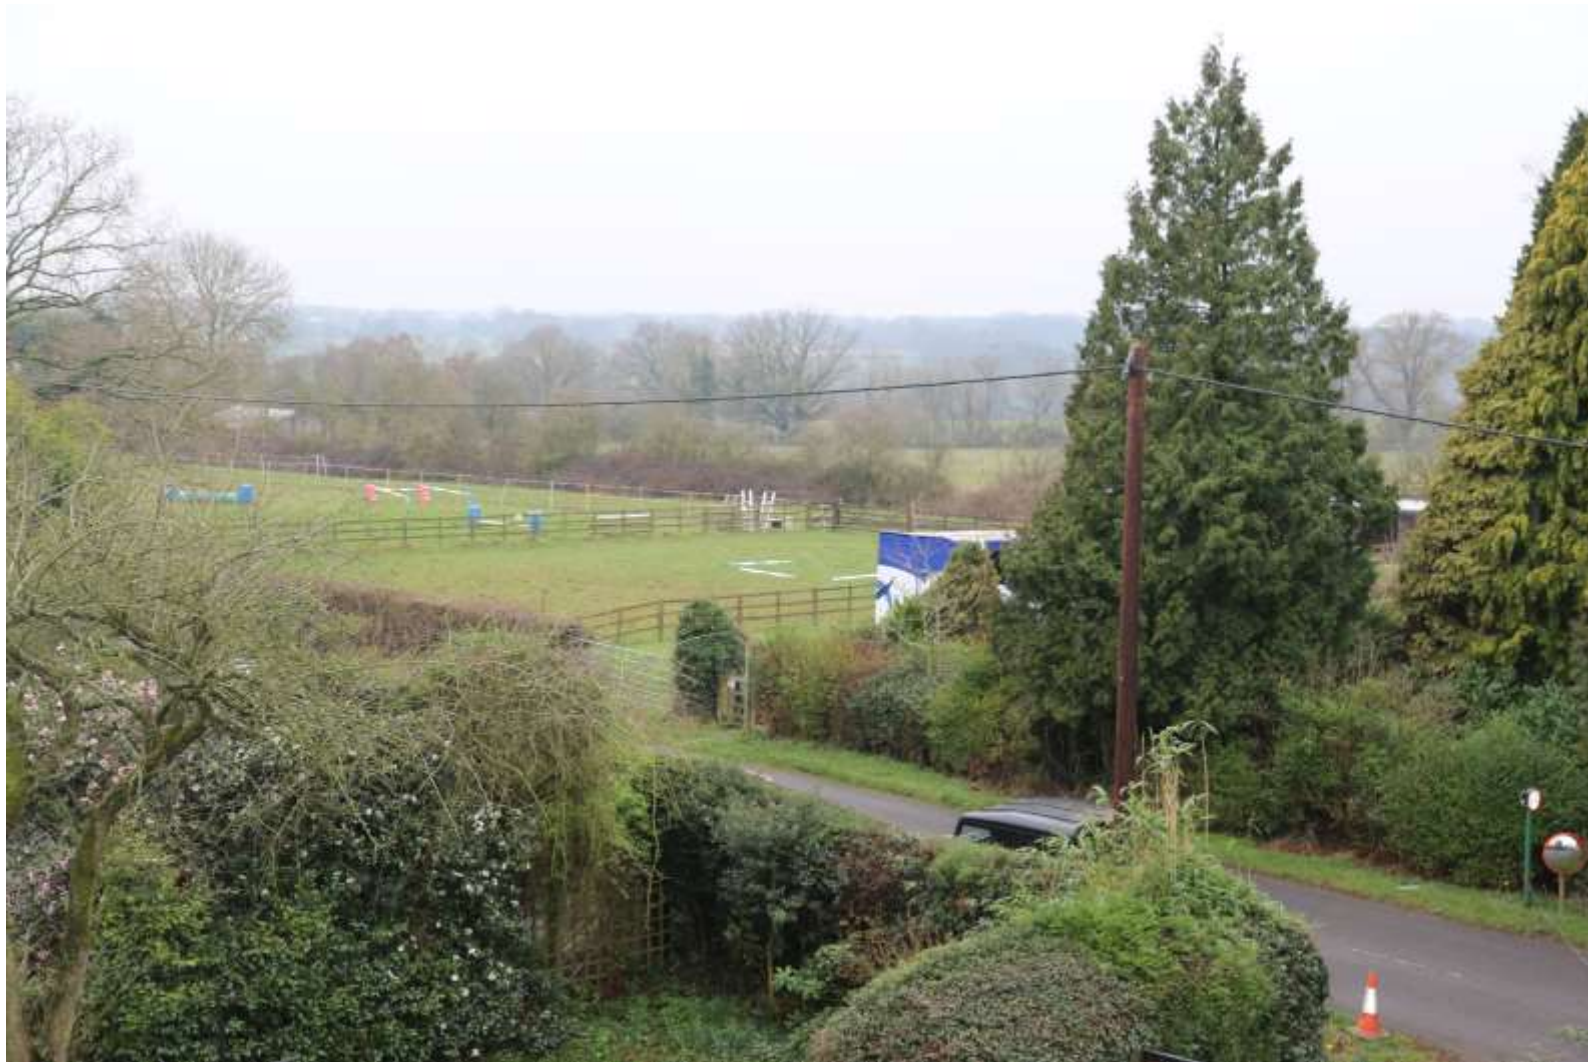
Figure 16 View from windmill to part of Site 3 adjacent to public footpath – trees in middle distance are along Kenilworth Road

2.6.21 The evidence demonstrates that there are clear views to parts of Site 3 from the windmill and this statement considers that development in the paddocks adjacent to Windmill Lane and south of the footpath would fail to preserve the setting of this Grade II\* building and would thus be contrary to Section 66 of the Act. It further considers that development here would cause significant harm to its setting as defined in the NPPF which requires that harm to the setting of Grade I or II\* assets should be wholly exceptional.

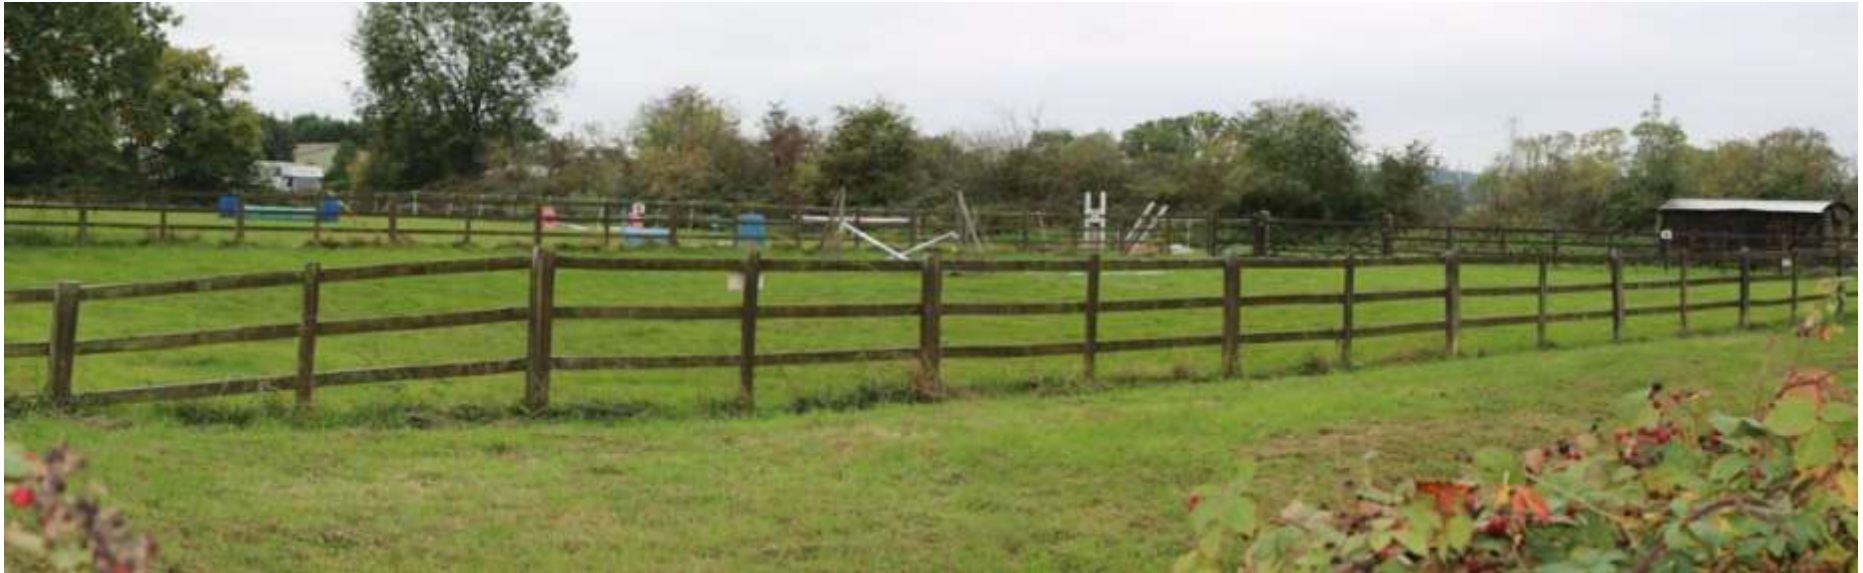
Figure 17 View into Site 3 from Windmill Lane at start of public footpath looking south to south-west

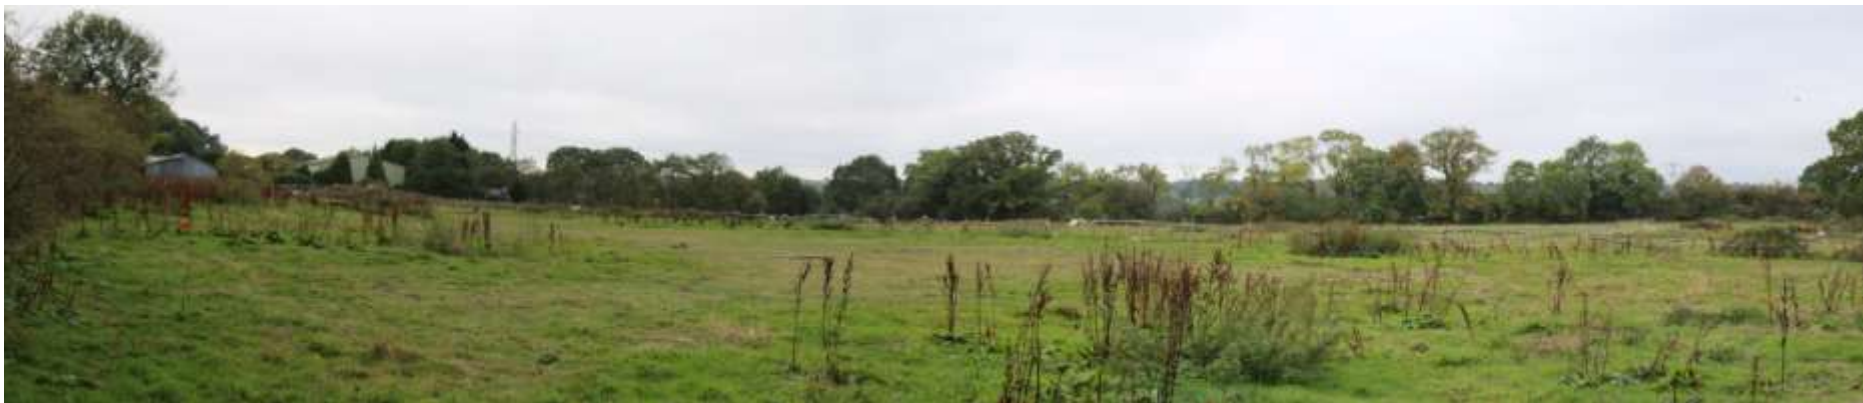
Figure 18 Panoramic view of Site 3 from footpath from Windmill Lane looking south to south west and Kenilworth Road

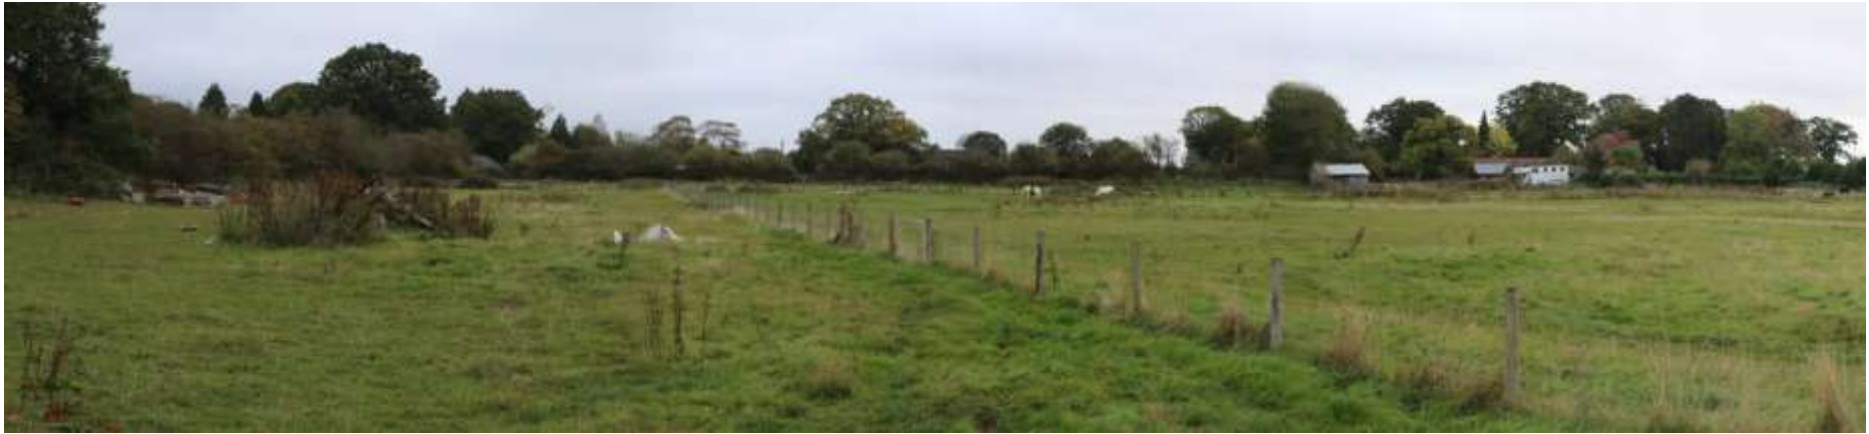
Figure 19 Panoramic view taken from field near footpath looking north-east to windmill and south-east along Windmill Lane

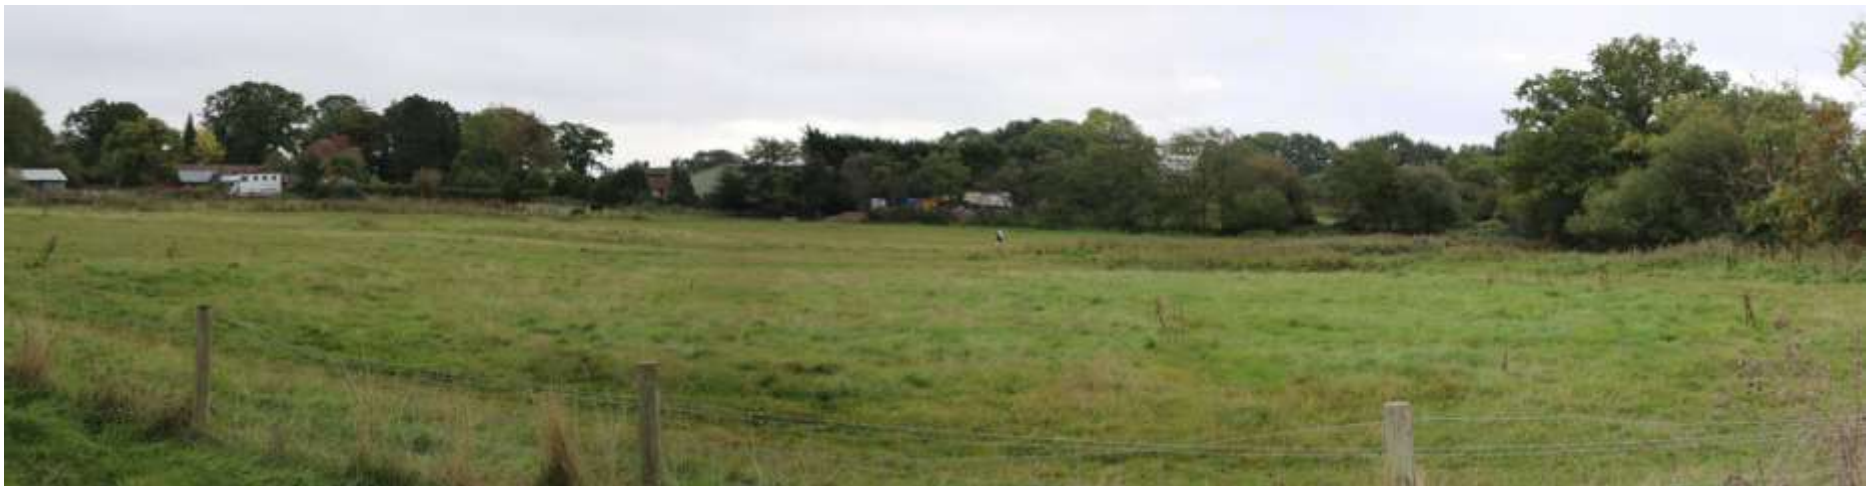
Figure 20 Panoramic view into Site 3 from public footpath looking south-east to south-west and Kenilworth Road

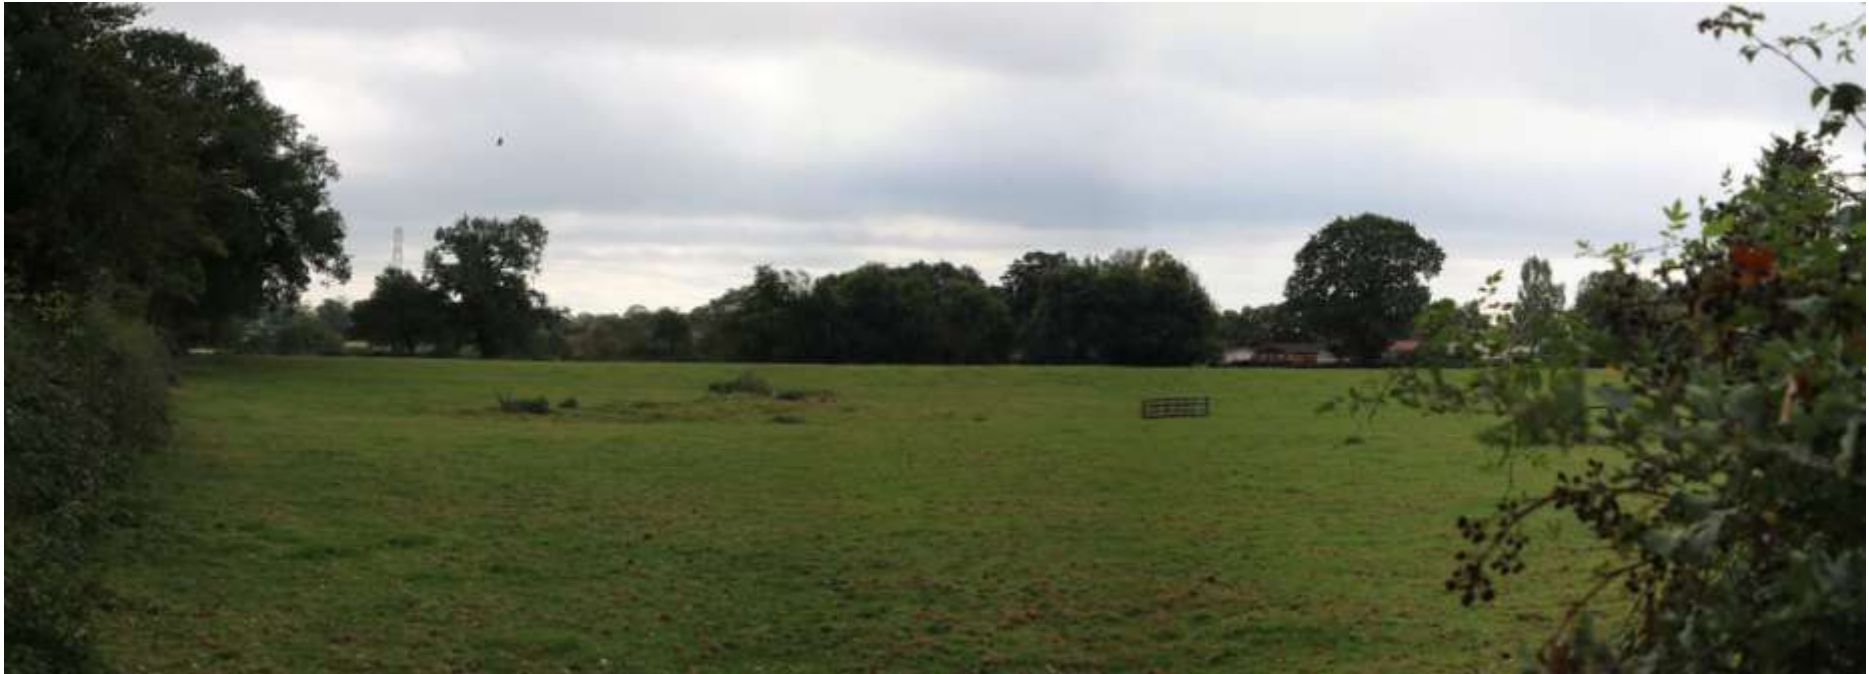
Figure 21 Panoramic view from field gate on Windmill Lane, north of Windmill, looking east to south-east and mobile homes site south of windmill
